SUBJECT**Rubbing and/or Scraping Noise from the Steering Column****MODEL**

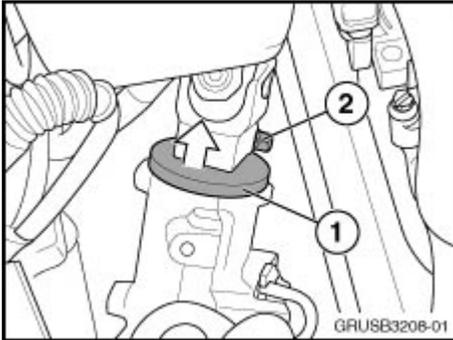
- Contact between the pinion shaft dust cover and the steering gear
- Insufficient lubrication of the bulkhead seal for the steering shaft

1. Using a pry bar or other suitable tool, push up slightly on the pinion shaft dust cover (1) while someone turns the steering wheel. If the noise changes or is eliminated, proceed to step 2. If the noise does not change, proceed to step 5.
2. Loosen the securing bolt (2) on the steering coupler.
3. Push the dust cap up to eliminate contact between the cap and the steering gear.
4. Refer to the Tightening Torque section of the Repair Manual for torque values and requirements for bolt replacement. **Tighten the securing bolt (2).**
